Sentinel R9.1.1 Release Notes

Release Date: February 2019

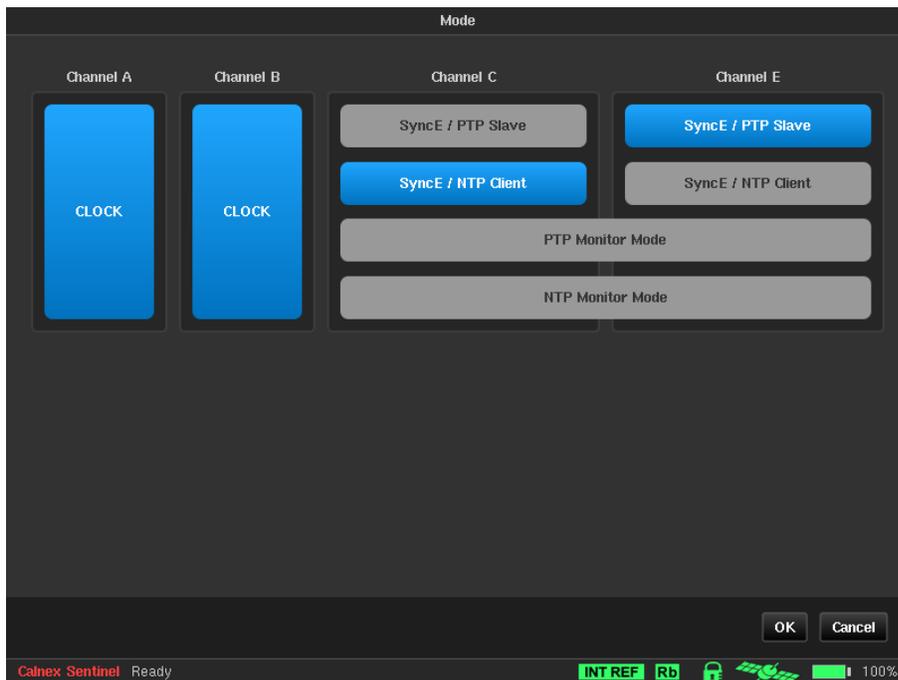
The **Mode** page now allows packet channels to be configured as **SyncE / NTP Client**.

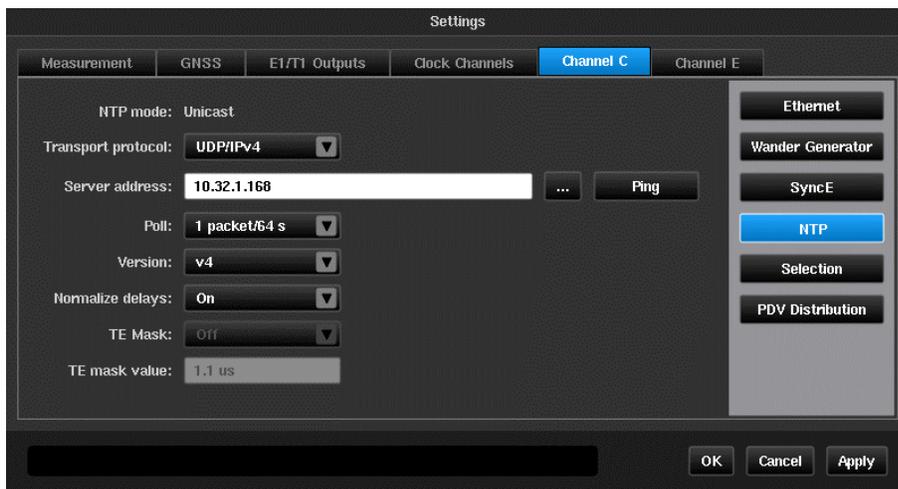
Selecting this option adds a **NTP** page to the **Settings->Channel x** tab.

Each channel can operate independently as PTP slave or NTP client. Selecting either PTP monitor mode or NTP monitor mode will automatically configure the other channel to the corresponding monitor mode.

Sentinel NTP client currently only supports operating in IPv4 unicast mode. Selecting **UDP/IPv6** from the **Protocol Level** dropdown will result in no measurement data being recorded.

The NTP client will start to poll at the rate specified in Poll and will continue to do so unless requested to increase the poll period by the NTP server. The poll rate can be configured as 1 packet every 2^n seconds, where $n=0$ to 17. This gives a maximum poll rate of 1 packet per second and a minimum poll rate of 1 packet every 36.4 hours.

Normalize delays selects whether packet delays are recorded as absolute values or as values relative to the first packet delay. To measure 2 Way Time Error **Normalize delays** should be set to **Off**.

Limits can be set for the 2 Way Time Error and displayed on the graph by setting **TE mask** to **On** and setting **TE mask value** to the test limit.

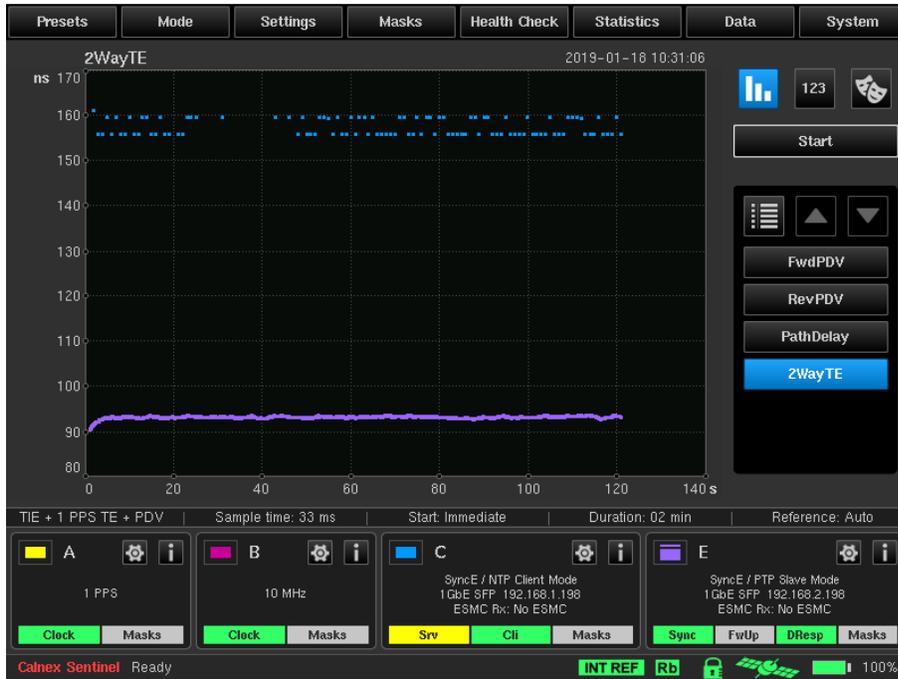
During the test the channel widgets display the status of the NTP message flow.

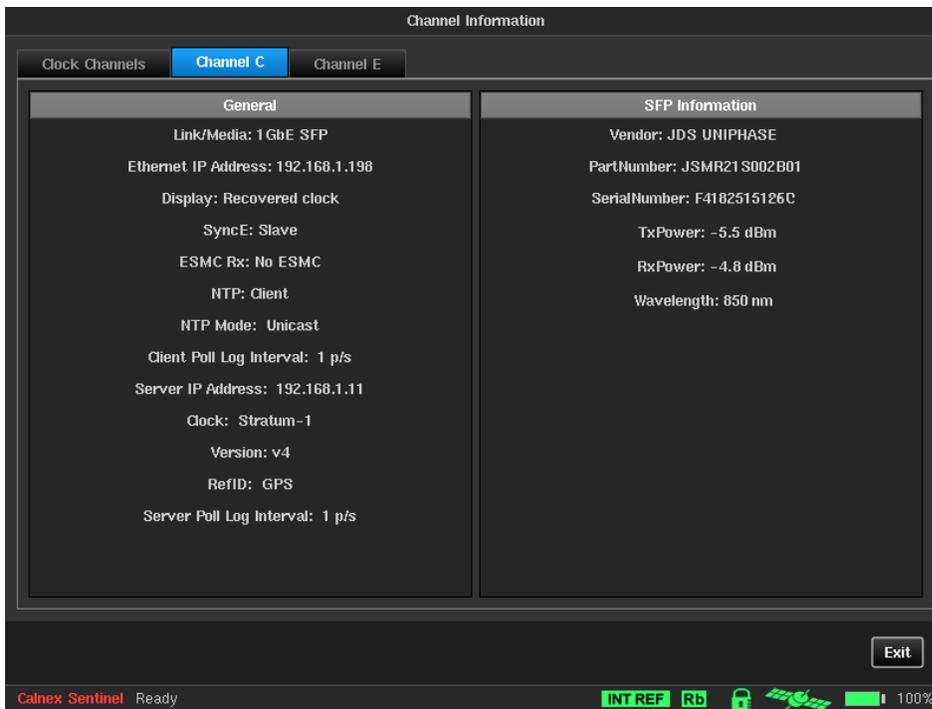
Further details including a decode of the information contained in the Server response can be obtained by pressing the **i** button.

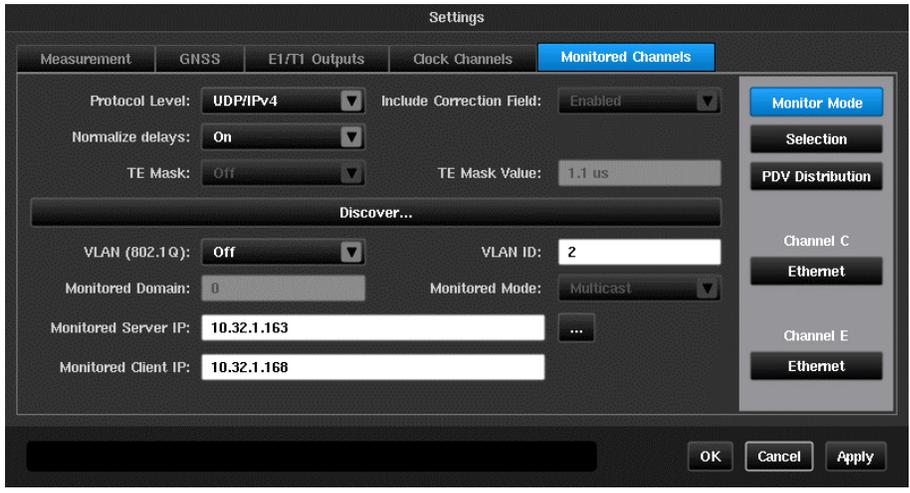
Selecting Monitor Mode operation brings up a single configuration tab on the **Settings** tab.

The flow to be monitored can be selected by pressing the **Discover...** button while the flow is active or manually entered in the **Monitored Server IP** and **Monitored Client IP** boxes.

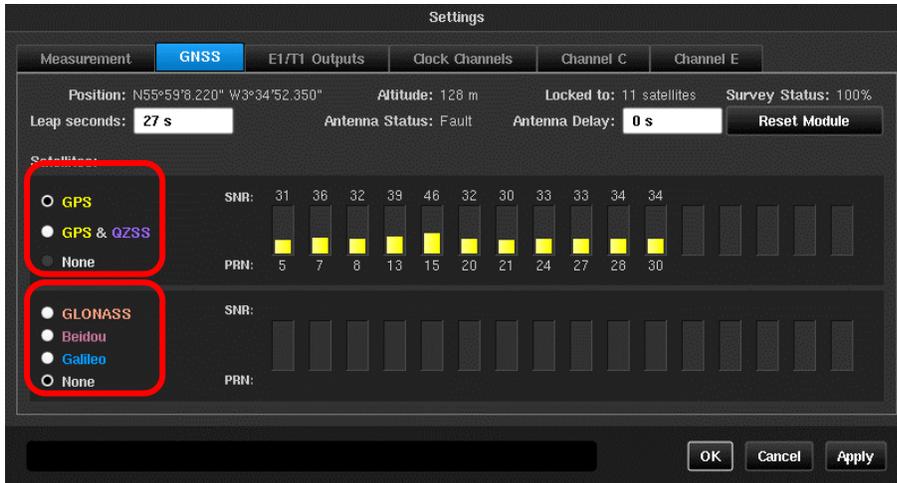
The GNSS module is configured from the Settings->**GNSS** tab.

The top constellation selection determines whether GPS is used and if GPS is selected, whether QZSS is also used. If GPS is not selected then a constellation must be selected in the lower selection area. For multi-constellation operation, Select GPS or GPS and QZSS and a secondary constellation.

Press Apply. This will cause the GNSS module to reset and begin a new site survey using the new constellation(s).

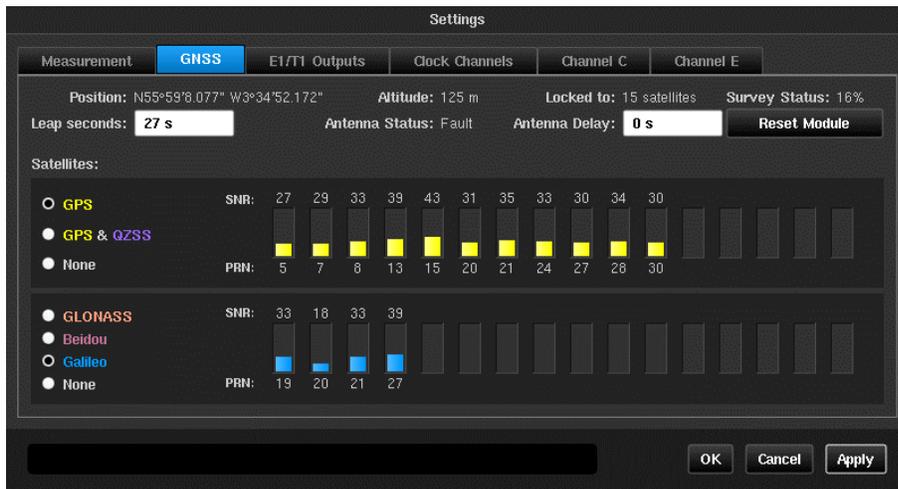
Satellite SNR status is shown in the same colour as the text in the constellation name. The **Locked to** status displays the total number of locked satellites over the multiple selected constellations.

GPS, Galileo and Beidou satellites transmit information that allows Sentinel to calculate the number of leap seconds that have occurred and this is used to determine the offset between TAI and UTC. The **Leap seconds** value is updated automatically whenever this information is received. GLONASS does not transmit leap second information and the **Leap seconds** must be manually entered if the current value is not correct. PTP uses TAI as the time base for its timestamps and if the **Leap seconds** value is incorrect it will show as whole seconds of offset in the FwdPDV, RevPDV and 2WayTE graphs.

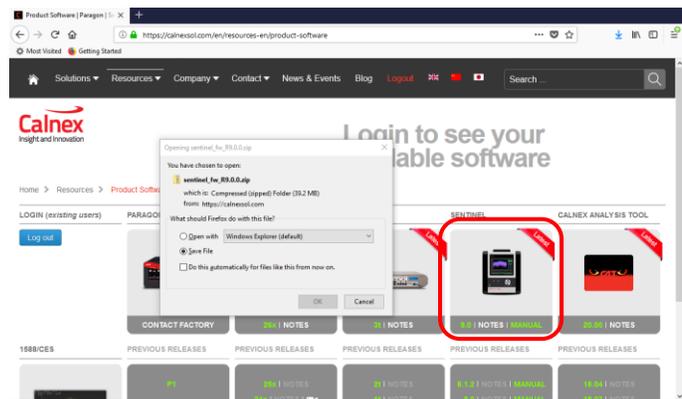
STEP 1

- In the **Resources > Product Software** page at <https://www.calnexsol.com> select the latest Sentinel firmware release.
- Save the file to a local disk.
- Unzip the **sentinel_fw_Rx.y.z.zip** file.
- Copy the **sentinel_fw_Rx.y.z.tar** file from the unzipped **sentinel_fw_Rx.y.z** folder to a blank USB drive.

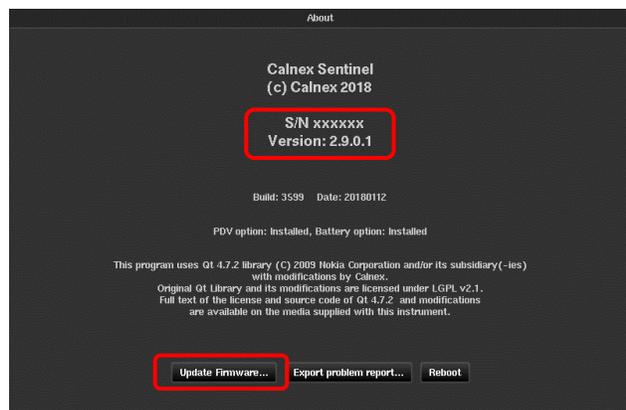
STEP 2

- Power on the Sentinel then plug the USB drive into the USB data port.
- Press the **Systems** tab then select the **About** button. This will show the Sentinel serial number and the current firmware revision.
- Press the **Update Firmware...** button.

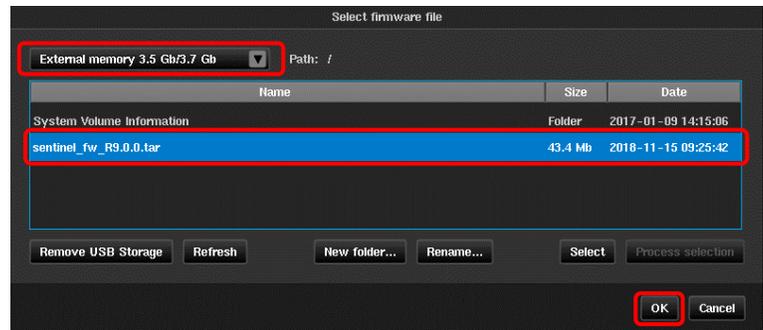
STEP 3

- Select **External memory** as the source.
- Select the **sentinel_fw_Rx.y.z.tar** file.
- Press **OK**.
- Sentinel will begin to extract the firmware.

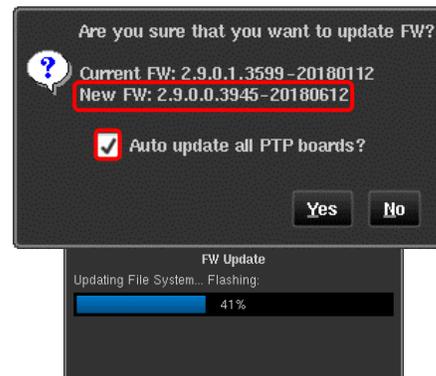
STEP 4

- Verify that the new firmware revision is correct.
 - Ensure that the **Auto update all PTP boards?** check box is selected.
 - Press **Yes**.
- Sentinel will now run through the firmware update, displaying progress on screen. When the upgrade has completed, Sentinel will re-boot automatically.
 - The PTP card(s) firmware version will be checked during re-boot and will be updated if required.

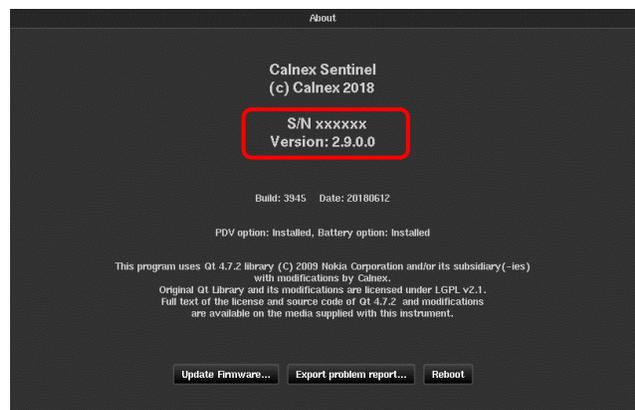
STEP 5

- Verify that the new firmware revision has been installed by checking the information on the **Settings > About** tab.
